DISTRICT OF TUMBLER RIDGE

DATE: JUNE 30, 2023

WATER SYSTEM ANNUAL REPORT 2022

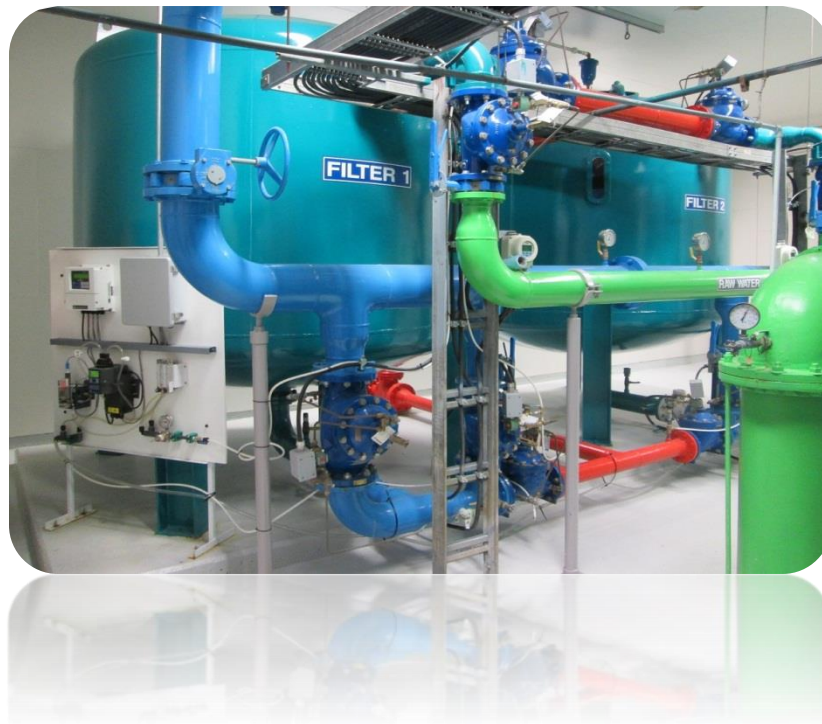
The average daily demand (ADD) in 2022 was approximately 2,580 m³/d. Per capita water use values can be informative for interpreting water use. With an assumed service population of 2399 people in 2022, provided by Statistics Canada 2021 census data, the ADD is 1205 L/cap/d. Figure 5-1 displays the total monthly water use in 2022

In 2022, the District used a total of approximately 912,035m³ of water (or 902 Million Litres).
